DEPARTMENT OF TRANSPORTATION

Quality Assurance and Source Inspection

Contract #: 04-0120F4Cty: SF/ALA Rte: 80 PM: 13.2/13.9File #: 1.28**WELDING INSPECTION REPORT****Resident Engineer:** Pursell, Gary**Address:** 333 Burma Road**City:** Oakland, CA 94607**Report No:** WIR-012632**Date Inspected:** 13-Mar-2010**Project Name:** SAS Superstructure**OSM Arrival Time:** 630**Prime Contractor:** American Bridge/Fluor Enterprises, a JV**OSM Departure Time:** 1700**Contractor:** American Bridge/Fluor Enterprises, a JV**Location:** Job Site**CWI Name:** Names listed below.**CWI Present:** Yes No**Inspected CWI report:** Yes No N/A**Rod Oven in Use:** Yes No N/A**Electrode to specification:** Yes No N/A**Weld Procedures Followed:** Yes No N/A**Qualified Welders:** Yes No N/A**Verified Joint Fit-up:** Yes No N/A**Approved Drawings:** Yes No N/A**Approved WPS:** Yes No N/A**Delayed / Cancelled:** Yes No N/A**Bridge No:** 34-0006**Component:** Orthotropic Box Girders**Summary of Items Observed:**

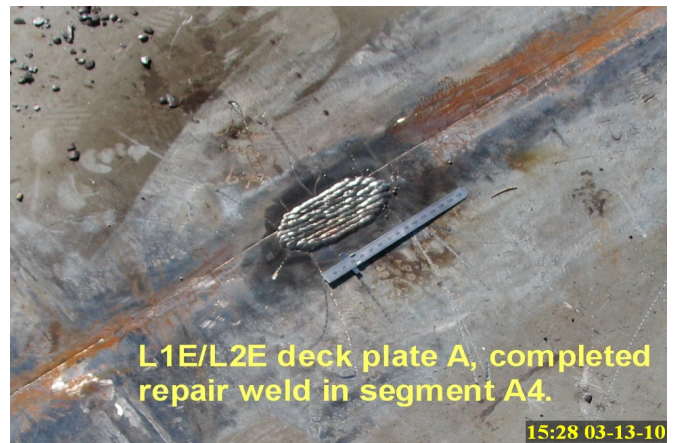
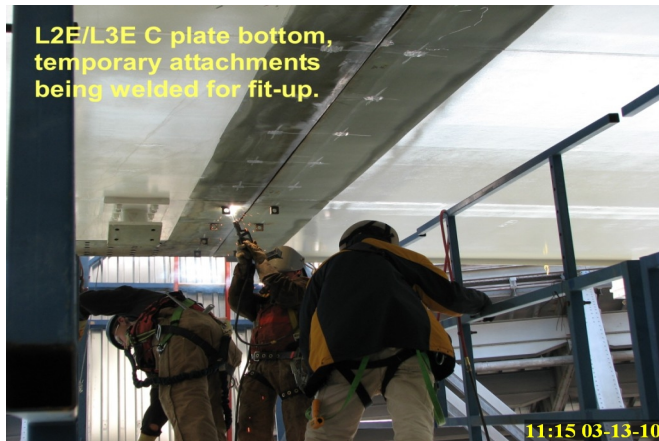
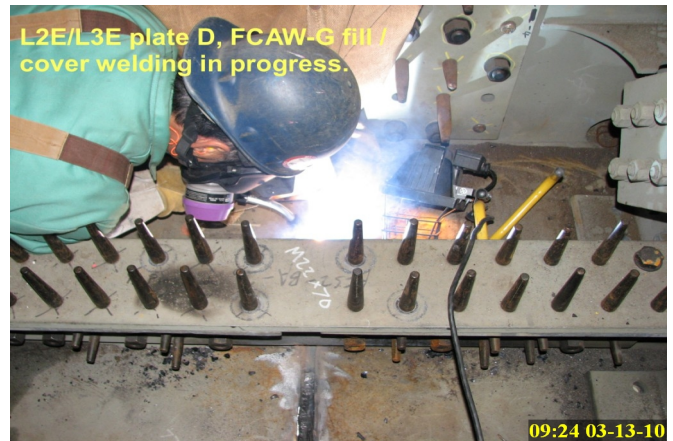
workmanship appeared to be generally conforming to the contract requirements. The QAI noted that ABF personnel are working to align the deck plate's horizontal plane (high-low) across the field splice. The QAI noted that the work was in progress and the joint fit-up has not been accepted by the QC Inspector at this time. See the attached photo.

5) The QAI observed ABF personnel making FCAW-G CJP welds at the L2E/L3E plate D field splice. The QAI noted that the QC Inspector James Cunningham is monitoring the welding at this location. The QAI was informed that fill and cover welds are being made in areas where submerged arc welding (SAW) could not be used to complete the splice welds. The QAI noted that Song Tao Huang, ID 3794 and James Zhen, ID 6001, are making the welds with ABF-WPS-D15-3040B-1. The QAI randomly measured the preheat, interpass temperature and welding parameters of the work in progress and noted that they appeared to be conforming to the WPS requirements. See the attached photo.
